14th Deep Sea Offshore Wind R&D Conference, EERA DeepWind'2017, 18-20 January 2017,
Trondheim, Norway

Fatigue behaviour of grouted connections at different ambient conditions and loading scenarios

Peter Schaumann^a, Alexander Raba^a, Anne Bechtel^b

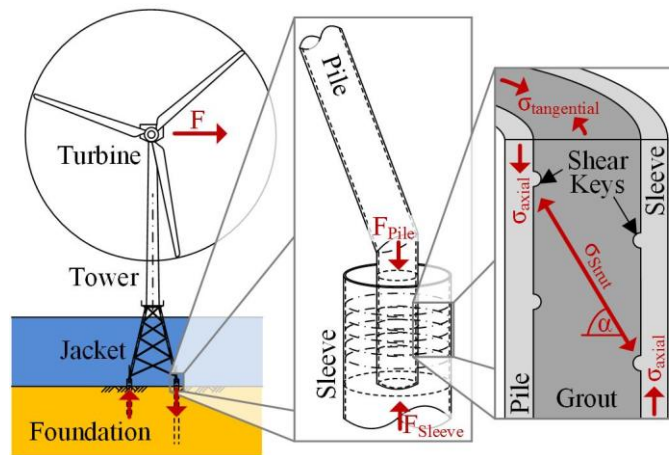
Fig. 1. Latticed substructure of an offshore wind turbine with structural details and load bearing behaviour of a grouted connection

Lattice substructures of offshore wind turbines and platforms, like tripods or the jacket shown in Fig. 1, are connected to their foundation piles via grouted connections. The connection is located just above the seabed and hence constantly submerged. A watertight sealing against ingress of surrounding water is usually not applied.

The load bearing behaviour of the substructure splits, from wind and wave loads resulting, bending moments into axial force couples acting on the foundation piles (cf. Fig. 1). Therefore, the grouted connections in this type of substructure are predominantly axially loaded. Inside the connection areas of concentrated compressive stresses occur

between opposing shear keys (σ_{strut}). Analogous to truss structures these areas are called compression struts. Due to the strut inclination angle α also radial stresses arise and are borne by circumferential stresses ($\sigma_{\text{tangential}}$) inside the steel tubes.

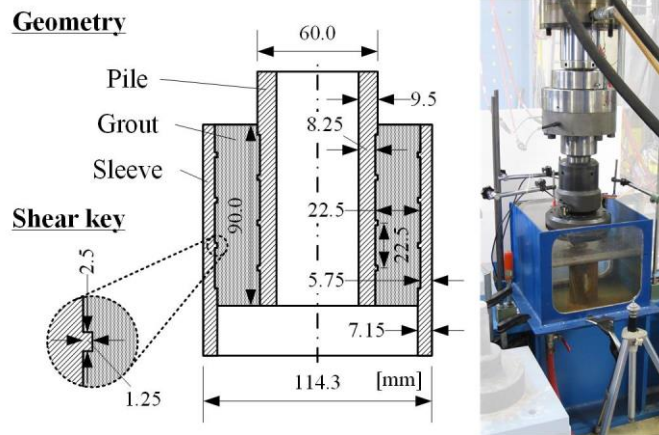
Fig. 2. Geometry of the small-scale specimen (left) and specimen in the test rig (right)

To simulate a realistic stress state inside the grout material, the small-scale specimen shown in Fig. 2 was developed [9]. Therefore, relatively compact steel tubes were chosen to prevent a failure of the steel tubes due to buckling or yielding. Rectangular shear keys were machined out of the steel surfaces. As filling material two commercial grout materials with a relatively low (Mat. 1, $f_{\text{cu}} = 90 \text{ N/mm}^2$) and a high strength (Mat. 2, $f_{\text{cu}} = 140 \text{ N/mm}^2$) were used.

The specimens were tested inside the water basin shown in Fig. 2. By the hydraulic cylinder pure axial compressive loads were applied. During the tests the applied load F , the relative displacement u of the load application plate and the number of applied load cycles N were measured.

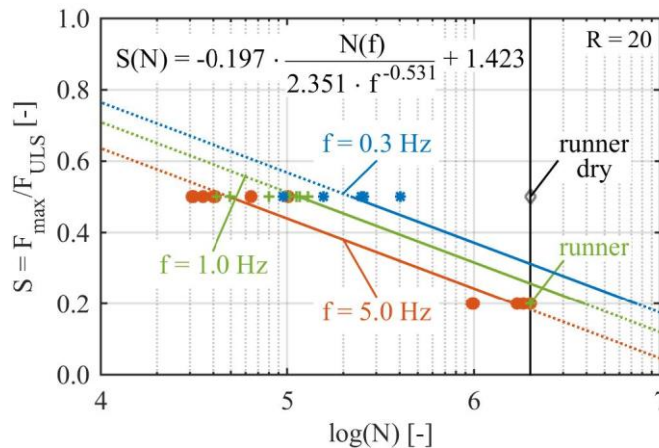
Fig. 3. Results of the small-scale fatigue tests and loading frequency dependent fatigue curve for wet ambient conditions

In Fig. 3 the obtained endurable load cycles N with their corresponding loading level S are depicted. Thereby S represents the ratio between the load bearing capacity F_{ULS} determined in quasi-static tests and the applied maximum compressive load F_{max} of the fatigue tests. In dry AC with a loading level of $S = 0.5$ and a loading frequency of $f = 5.0$ Hz all specimens reached the test termination criterion of $N = 2$ million load cycles. In wet AC and identical loading conditions the specimens failed at an average of $N = 50'000$ load cycles. Prior tests [11] had already shown no specimen degradation in dry AC at this loading level. This can be explained by the static load bearing behaviour of the specimen, which is almost linear elastically up to this loading level [12]. The differences between the results obtained in dry and wet AC lead to the conclusion, that in wet AC different damage mechanisms occur.

A reduction of the loading frequency leads to an increased number of endurable load cycles. Based on these results the frequency dependent fatigue curves for small-scale specimens shown in Fig. 3 were developed [13]. These findings are remarkable because prior investigations [6, 8] for specimens without confining steel tubes showed a contrary influence of the loading frequency. Ergo, the damage process is influenced by the interaction of steel and grout.

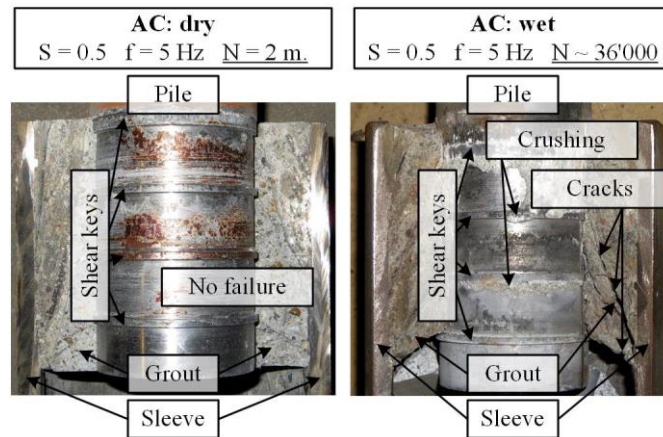
Fig. 4. Damage patterns of dismantled small-scale specimens

After completion of the fatigue tests the specimens were dismantled. In Fig. 4 one dismantled specimen tested in dry and one tested in wet AC are shown. While the specimen tested in dry AC shows no visible degradation in the grout segment, the other specimen shows compression strut failure in the lower grout segment, grout crushing in front of the shear keys of the pile and vertical cracks at the upper interface between grout and pile.

Conclusively, the damage behaviour can be described as follows. Until the fatigue tests start, the specimens are stored in a water basin. Therefore, at the beginning of the tests the grout segment is saturated with water. Applying the load, compresses water inside the specimen and presses water out of the interface between steel and grout. In dry AC this process is terminated after a few load cycles. In wet AC unloading the specimen leads to water being sucked into the interface again, a pumping process occurs. Additionally, pressurised water leads to local grout crushing at lower load levels than in dry AC. In combination with grout crushing caused by the local load application of the shear keys, crushed material particles accumulate in the interface. By the pumping process the grout particles are flushed out of the connection and an increase of relative displacement between pile and sleeve occurs. This damage behaviour leads to less endurable load cycles of grouted connections in wet AC.

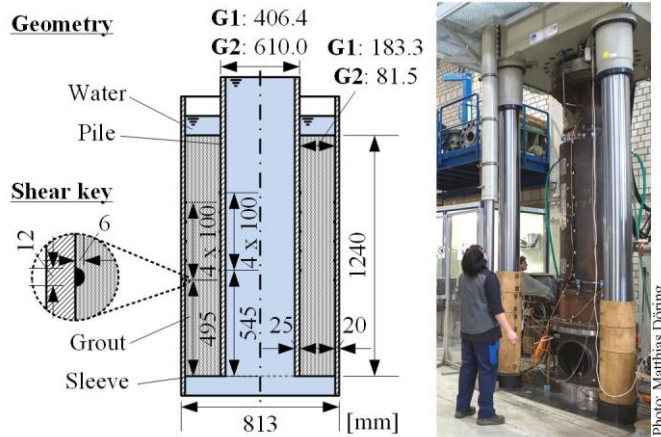
Fig. 5. Geometry of the large-scale specimen (left) and specimen in the test rig (right)

Subsequently, two large-scale fatigue tests were carried out in wet AC to investigate the influence of water on the fatigue behaviour of the connection. Using the grout material with higher strength (Mat. 2) the two geometries (G1 and G2) shown in Fig. 5 were investigated. The two geometries differ in the diameter of their pile and therefore in the thickness of their grout layer.

In contrast to the small-scale specimens with compact steel tubes, the large-scale specimens were developed as scaled versions of real structures (G1: ~ 1:2 jacket, G2: ~ 1:4 tripod) [14]. Similar to real structures, the shear keys were made of weld beads with the dimensions given in Fig. 5.

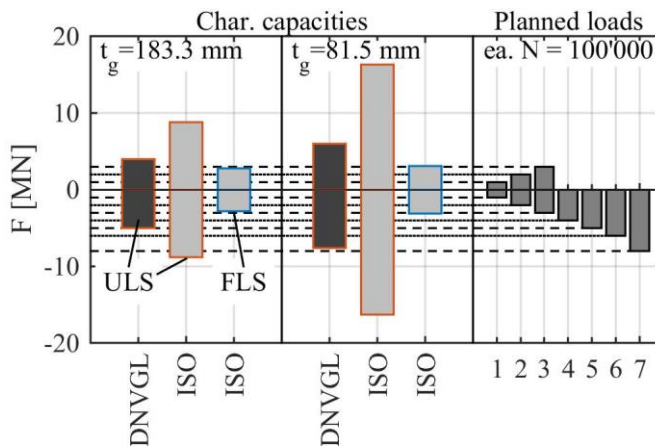
Fig. 6. Calculated characteristic capacities of the large-scale specimens and planned load scenario of the fatigue tests comprising 7 load stages

Fig. 6 shows the load bearing capacities of the specimens according to current design methods [1, 2] as well as the planned load scenarios. The load scenarios were chosen to be incrementally increased each after 100'000 load cycles. Thereby, different load stages could be investigated and a fatigue induced failure was expected to be provoked [14]. The first three load stages (LS) were alternating loads ($R = -1$) and the following load stages were pure compressive loads ($R \rightarrow \infty$). The loading frequency was 1 Hz.

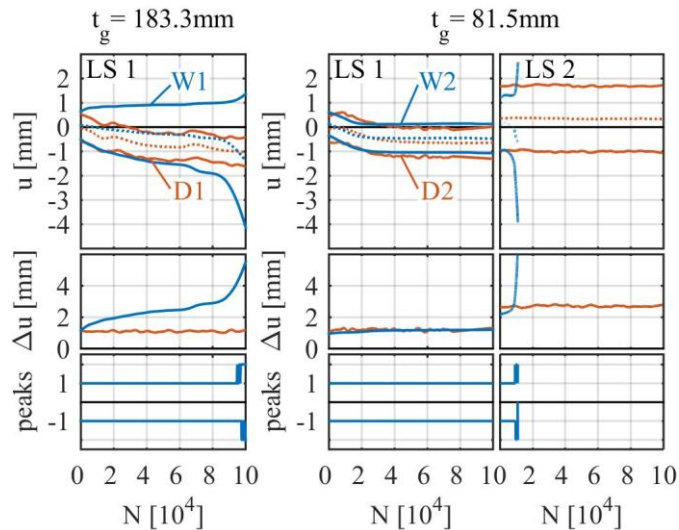
Fig. 7. Displacement behaviour of the specimens in different ambient conditions (D = dry, W = wet) in dependency of the number of load cycles

As shown in Fig. 7 for specimen W1 a continuous increase of the displacement range $\Delta u(N_i) = u_{\max}(N_i) - u_{\min}(N_i)$ per load cycle N was measured. The hysteretic loop evolution depicted in Fig. 8 elucidates that the displacement increase is localised around the load's zero crossing. At the same time the specimen's stiffness remains constant, which can be derived from the inclination of the hysteretic loops. This behaviour implies a damage of the interface between steel and grout and will be called connection backlash in the further description. At the end of LS1 the displacement increase rises significantly and a second peak per half hysteretic loop evolves (cf. Fig. 7). From this point on the connection shows no further stable load bearing behaviour. Hence, the occurrence of a second peak was chosen as failure criterion to define the endurable load cycles given in Table 1.

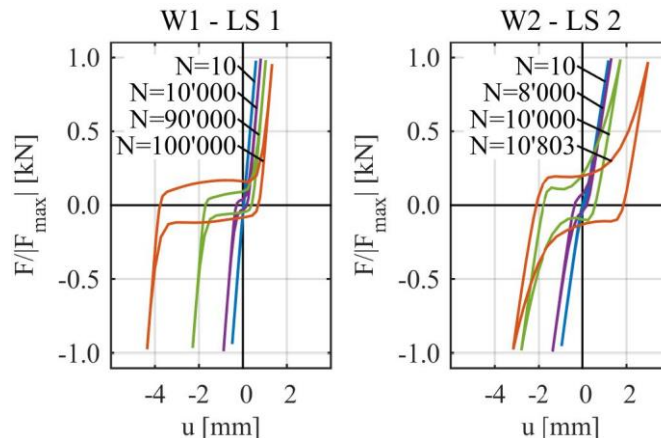
Fig. 8. Normalised hysteretic loop evolution for the load scenarios of specimen failure of the specimens tested in wet AC

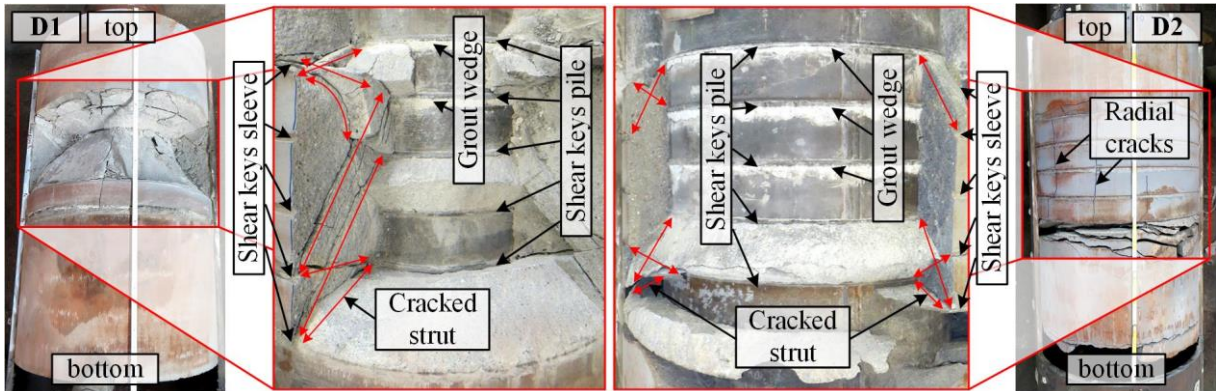
Fig. 9. Damage patterns of dismantled specimens D1 and D2

After completion of the fatigue tests the large-scale specimens were dismantled and the damage mechanisms were analysed. The specimens tested in dry AC showed a severely damaged grout layer with loose grout particles and segments (cf. Fig. 9). Both specimens D1 and D2 had cracks along the compression strut axes. The compression strut cracks were caused by tensile as well as compressive loading of the different load stages. Consequently, in both geometries crossing compression strut cracks occurred. The damage patterns imply, that in dry AC compression strut failure is the dominating failure mechanism. Besides the diagonal cracks, especially in the geometry with large grout

layer thickness, radial cracks were visible even before the tests started. Both crack types led to a severely damaged grout layer for the specimen with large grout layer thickness D1. In front of the shear keys also grout crushing occurred and a grout wedge similar to the investigations by Krahl & Karsan [16] was visible. Even though, the grout material showed brittle cracking, the specimens' failure was characterised by a ductile behaviour. The number of endurable load cycles was higher than expected. More details can be found in [14].

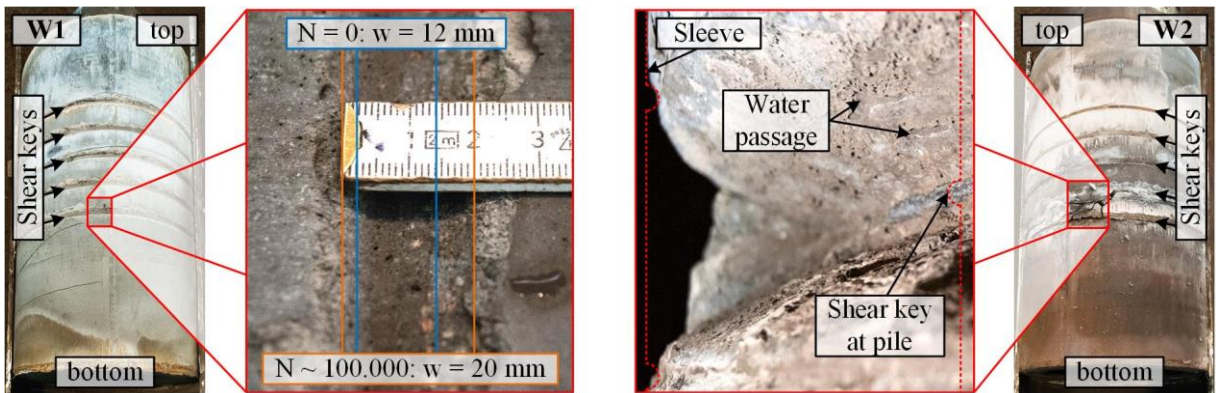
Fig. 10. Damage patterns of dismantled specimens W1 and W2

For the specimens tested in wet AC W1 and W2 the damage pattern is localised to the interface between sleeve and grout. This is remarkable, since this interface is less stressed due to its larger surface area. Both of the previously described displacement increase can be traced back to the widened grout groove around the shear keys, depicted in Fig. 10. In specimen W2 compression strut failure in the lower grout segment was visible. This crack occurred slightly before the specimen failed in LS2.

Based on the gathered data the damage mechanism of the specimens tested in wet AC can be described as follows. The local load application of the shear keys leads to grout crushing as also seen in the dry AC tests. The loosened grout particles are subsequently flushed out of the interface by the pumped water and the shear key groove widens. The connection backlash evolves and an impulsive load application after the load's zero crossing occurs. A speed up degradation results. The previously mentioned additional peak of the half hysteric loop correlates with the impulsive load. When considering the occurrence of the connection backlash after only a few load cycles, as shown in Fig. 8, an initial weakening of the interface between sleeve and grout must be assumed. This can be explained by autogenous shrinkage which leads to detached grout.
